STRATA PLAN BCS 2237 – The GALLERIA
5649 & 5689 Kings Road, Vancouver, BC

Contingency Reserve Fund Study /
Depreciation Report:

Prepared by:
SPRATT EMANUEL ENGINEERING LTD.

May 25, 2026
Our File No.: M25-347

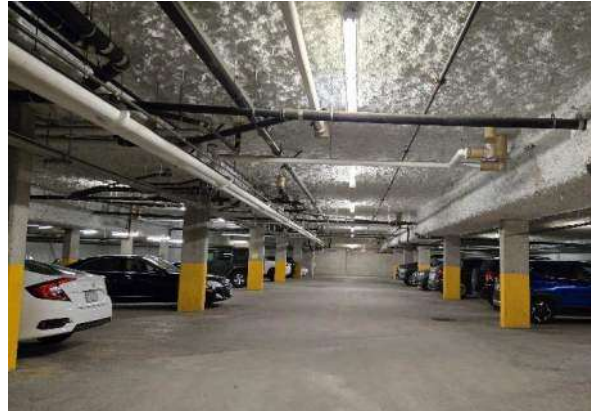
1.2 Parkade

The parkade structure was noted to be in good condition with no visible issues been identified.

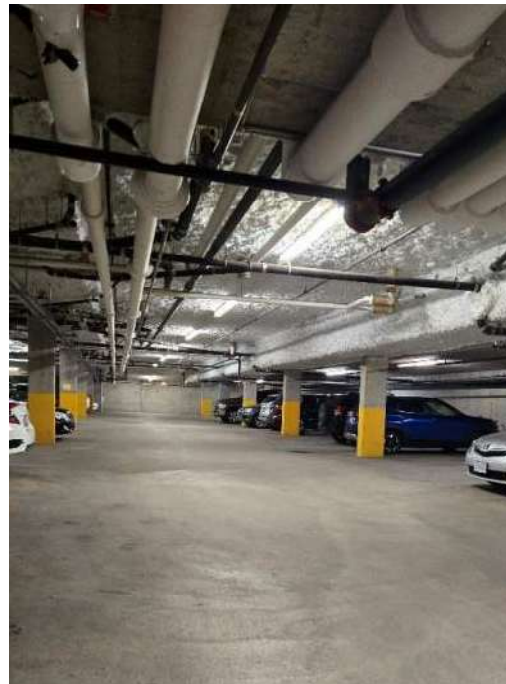
1.2 Parkade

The parkade structure was noted to be in good condition with no visible issues been identified.

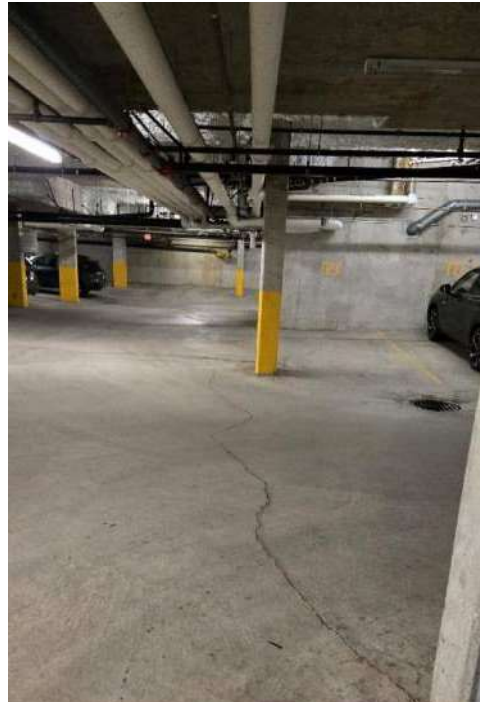
1.2 Parkade

The parkade structure was noted to be in good condition with no visible issues been identified.

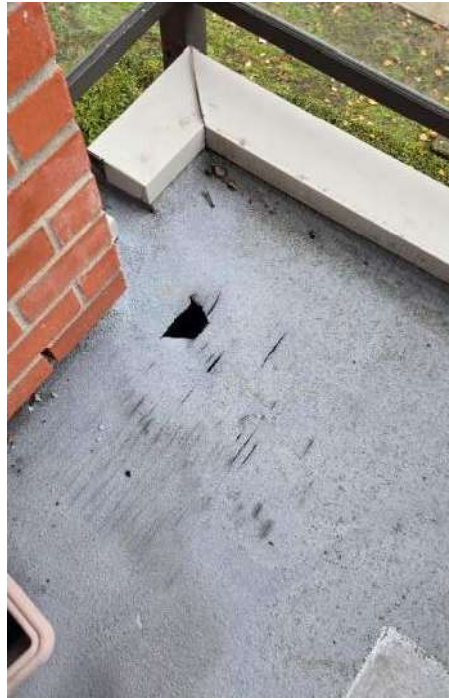
3.4.1 Balconies – Waterproofing Membrane

The balcony wood frame decking is protected with polyurethane traffic membranes. Damage to the underlying wood structure has occurred.

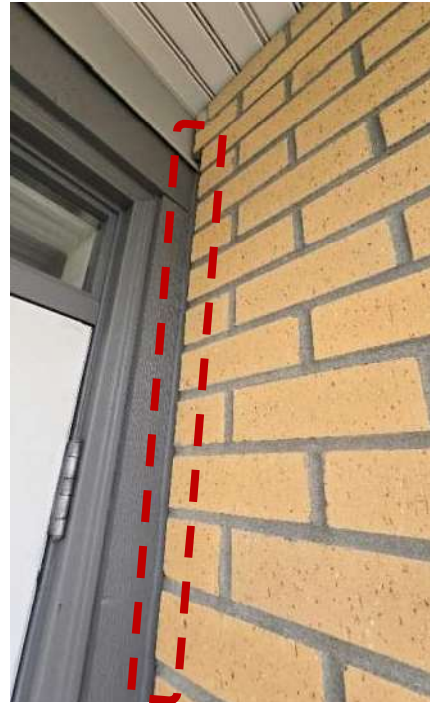
4.3 Sealants

Sealants were noted to be in generally good to fair condition. No failed sealants were noted during the review.

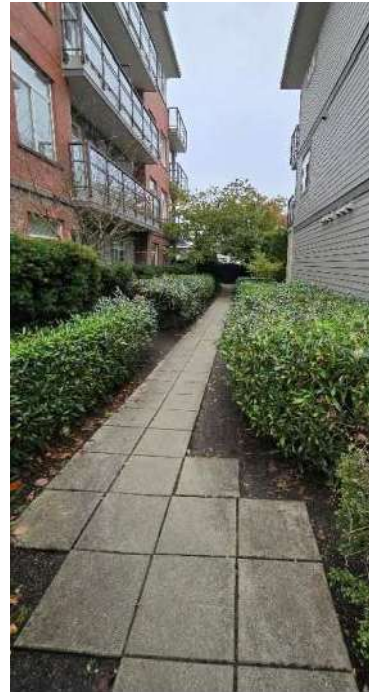
6.1.1 Concrete Walkways

Concrete paver walkways are generally in fair condition; however, several localized areas present trip-and-fall hazards that require immediate attention.

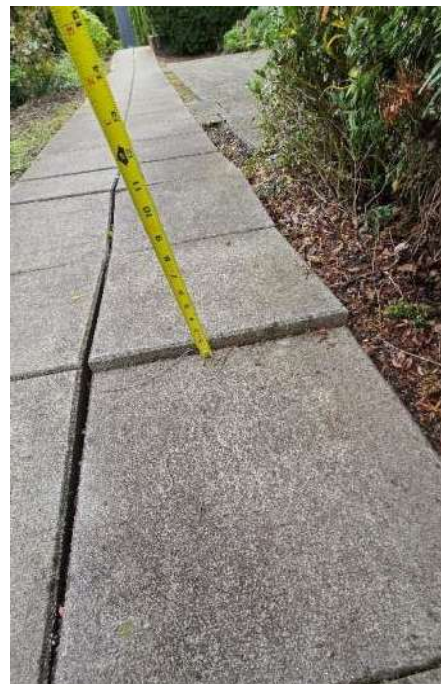
6.1.1 Concrete Walkways

Concrete paver walkways are generally in fair condition; however, several localized areas present trip-and-fall hazards that require immediate attention.

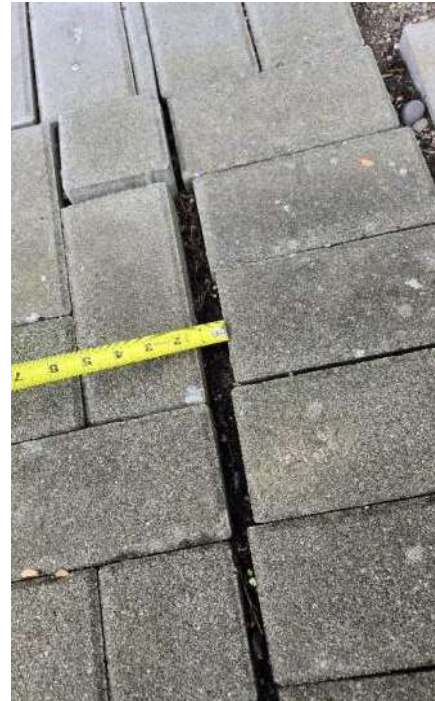
6.1.1 Concrete Walkways

Concrete paver walkways are generally in fair condition; however, several localized areas present trip-and-fall hazards that require immediate attention.

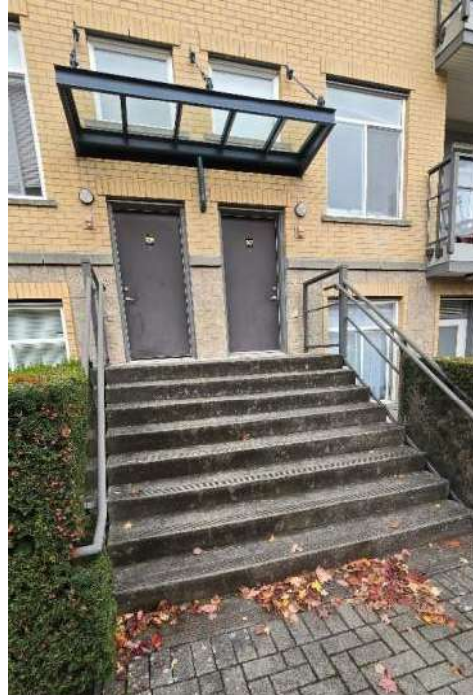
6.1.3 Concrete Stairs, Curbs and Retaining Walls

This section includes all the concrete hard landscaping which includes the concrete stairs, concrete curbs, retaining walls, and sidewalks. These items should require little maintenance throughout the life of the building and were observed to be in fair condition currently with no observed cracks.

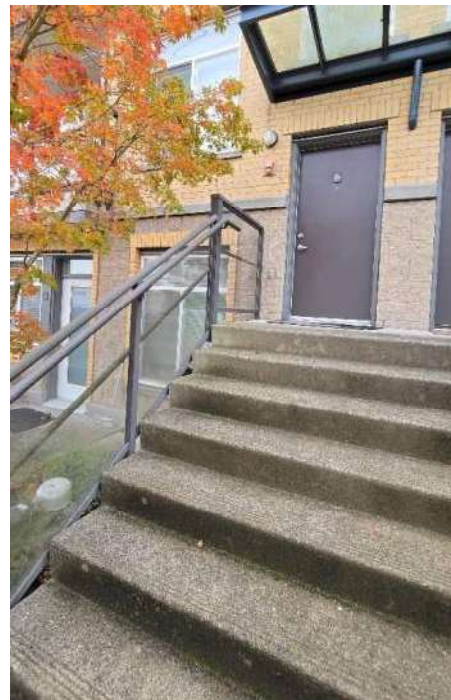
6.2 Metal Railings

Exterior stairs, and yards are outlined with painted metal railings and metal gates. The metal railings were noted to be in fair condition.

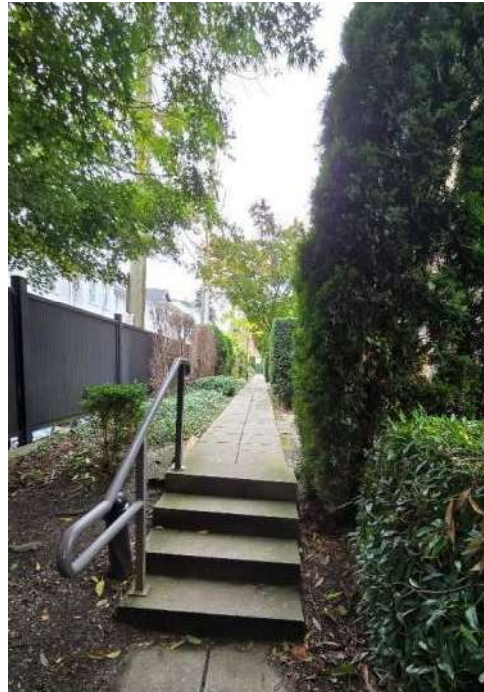
6.2 Metal Railings

Exterior stairs and yards are outlined with painted metal railings and metal gates. The metal railings were noted to be in fair condition.

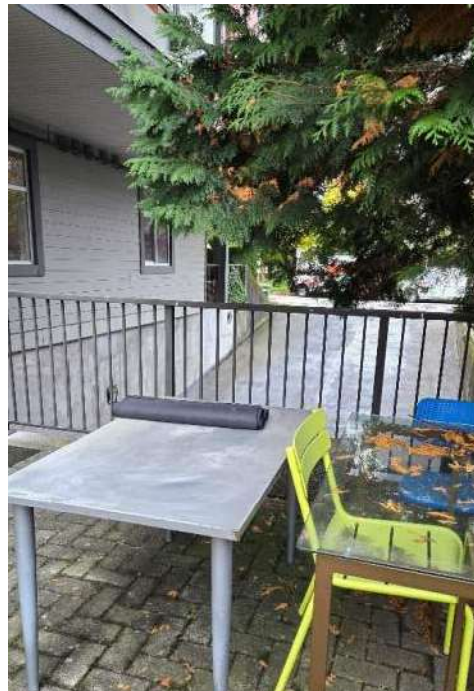
6.2 Metal Railings

Exterior stairs and yards are outlined with painted metal railings and metal gates. The metal railings were noted to be in fair condition.

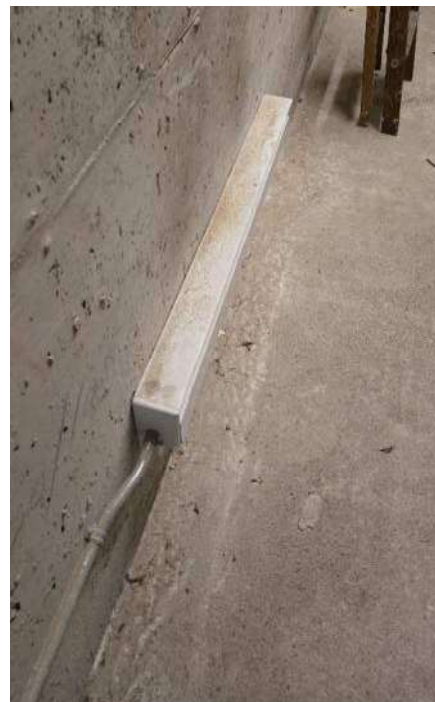
7.1.1 Electric Baseboard Heaters

Common areas and service rooms are heated with individual wall mounted electric baseboard heaters with thermostats in each room. The electric heaters appear to be in fair condition and would be repaired or replaced out of the operating budget.

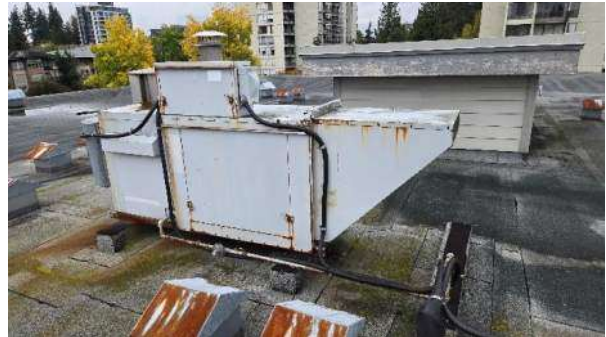
7.1.2 Packaged Rooftop Unit (RTU)

The “Engineered Air” RTU overtop of Building A is in good condition.

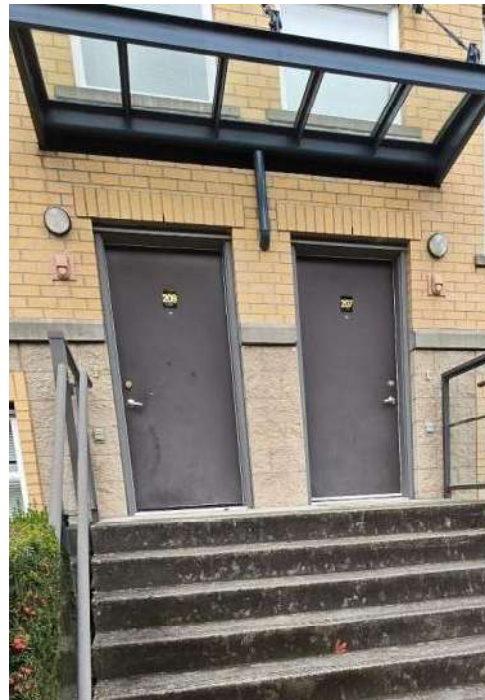
8.1.3 Exterior Light Fixtures

There are sets of exterior wall-mounted light fixtures that focus on the pathways within the Galleria development at unit entrances and at exterior walls overlooking balconies. The exterior light fixtures are in fair condition where observed.
