STRATA PLAN BCS 2237 – The GALLERIA
5649 & 5689 Kings Road, Vancouver, BC

Contingency Reserve Fund Study /
Depreciation Report:

Prepared by:
SPRATT EMANUEL ENGINEERING LTD.

May 25, 2026
Our File No.: M25-347

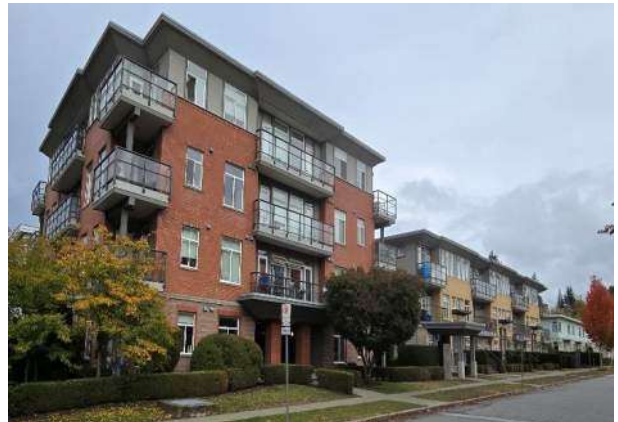
1.1 Building

The development consists of a multi-unit four-storey condominium building and three-storey townhouse buildings. The building structures are of wood frame construction, built over a single-level, conventionally reinforced concrete parkade.

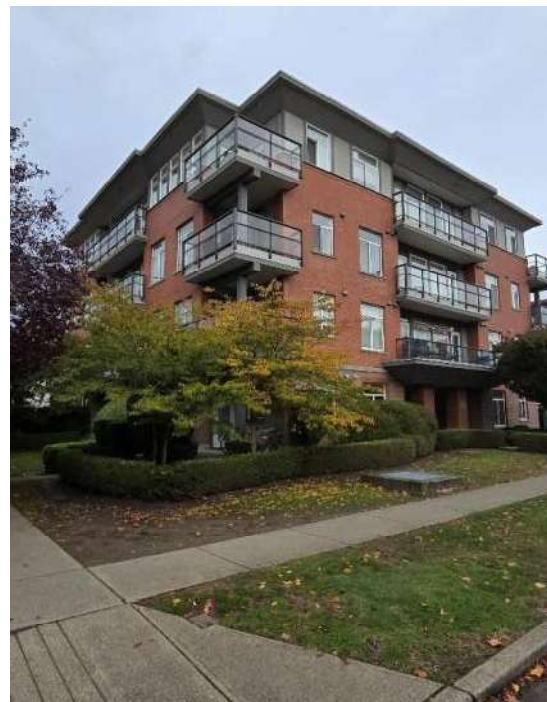
1.1 Building

The development consists of a multi-unit four-storey condominium building and three-storey townhouse buildings. The building structures are of wood frame construction, built over a single-level, conventionally reinforced concrete parkade.

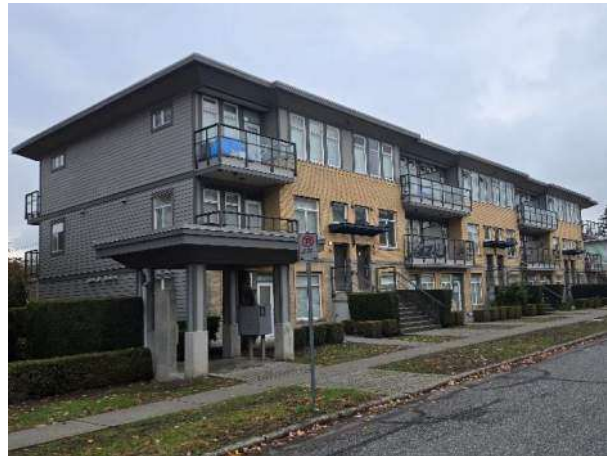
1.1 Building

The development consists of a multi-unit four-storey condominium building and three-storey townhouse buildings. The building structures are of wood frame construction, built over a single-level, conventionally reinforced concrete parkade.

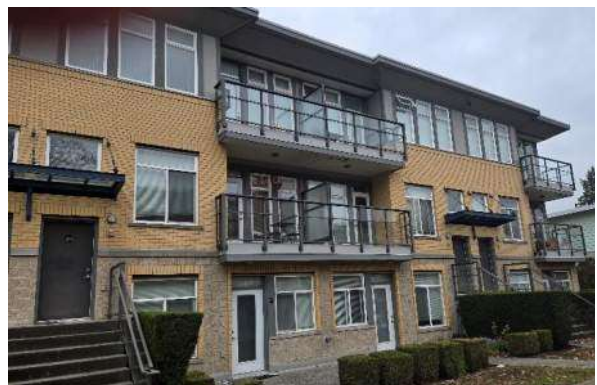
1.1 Building

The development consists of a multi-unit four-storey condominium building and three-storey townhouse buildings. The building structures are of wood frame construction, built over a single-level, conventionally reinforced concrete parkade.

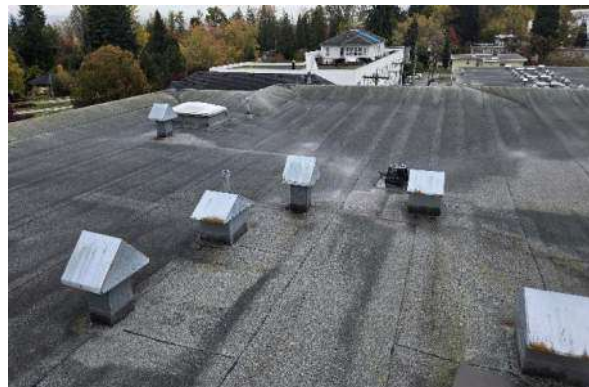
2.1 Roof System

The main roof system atop the buildings is a low sloped SBS roof system.

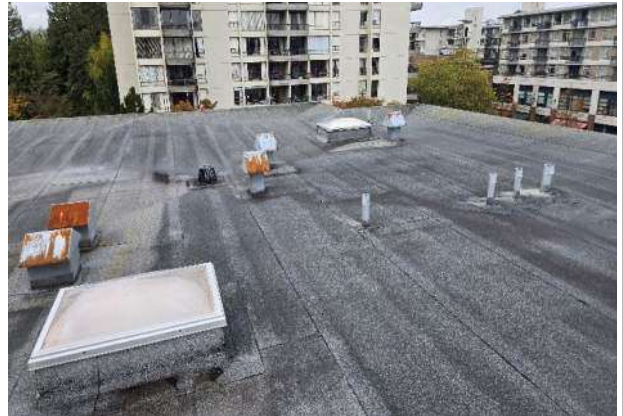
2.1 Roof System

The main roof system atop the buildings is a low sloped SBS roof system.

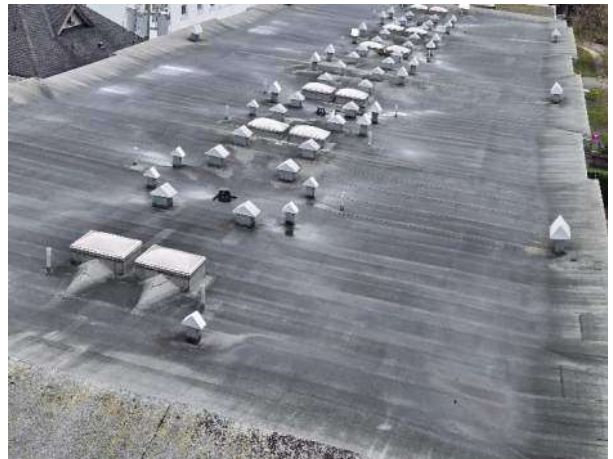
2.1.1 Low-Sloped Roof

The main roof system atop the buildings is a low sloped SBS roof system.

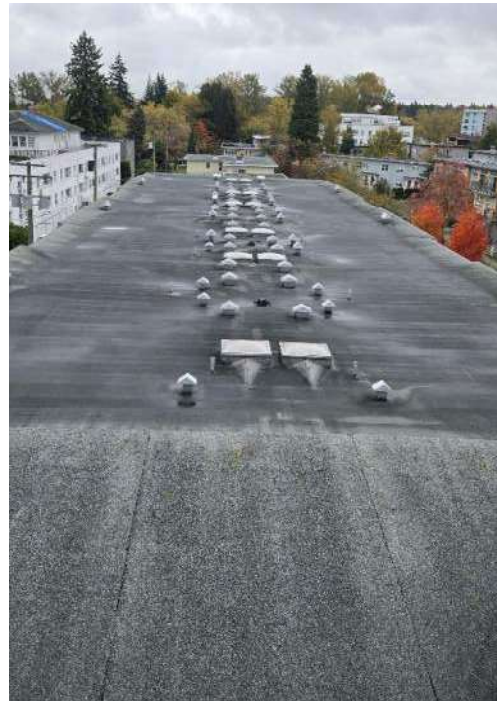
2.1.1 Low-Sloped Roof

The main roof system atop the buildings is a low sloped SBS roof system.

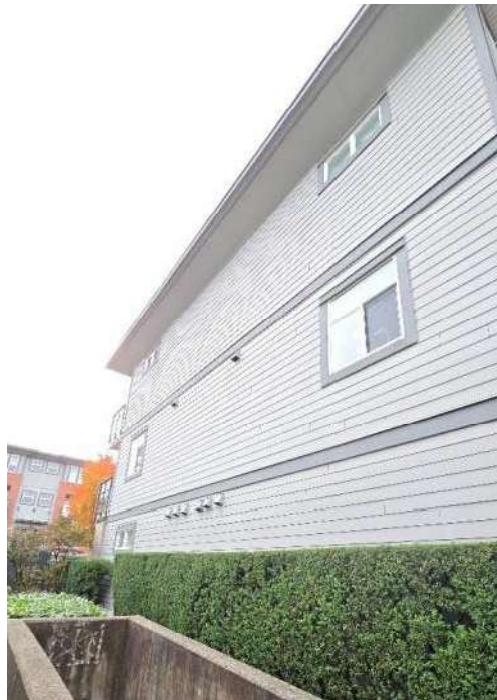
3.0 Exterior Walls

The building exterior wall surfaces have been cladded with rainscreen fibre cement cladding.

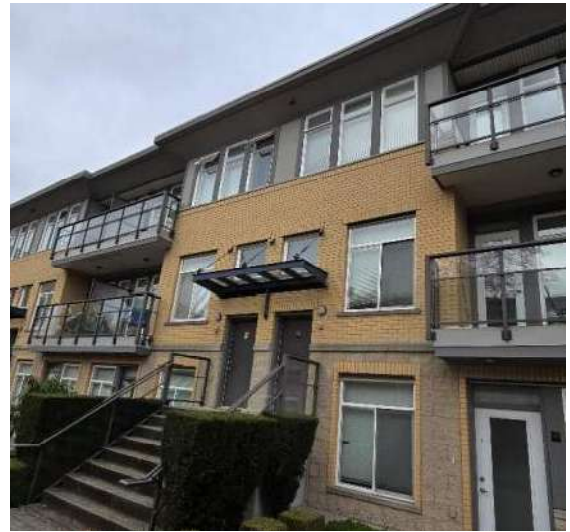
3.0 Exterior Walls

The building exterior wall surfaces have been cladded with rainscreen fibre cement and masonry cladding.

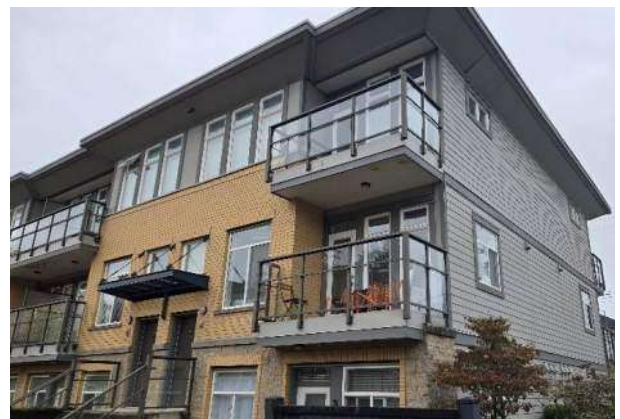
3.0 Exterior Walls

The building exterior wall surfaces have been cladded with rainscreen fibre cement and masonry cladding.

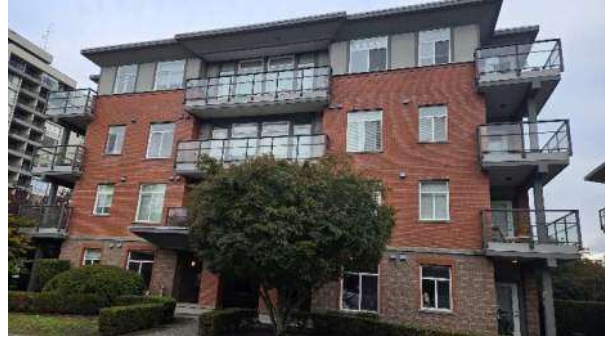
3.0 Exterior Walls

The building exterior wall surfaces have been cladded with rainscreen fibre cement and masonry cladding.

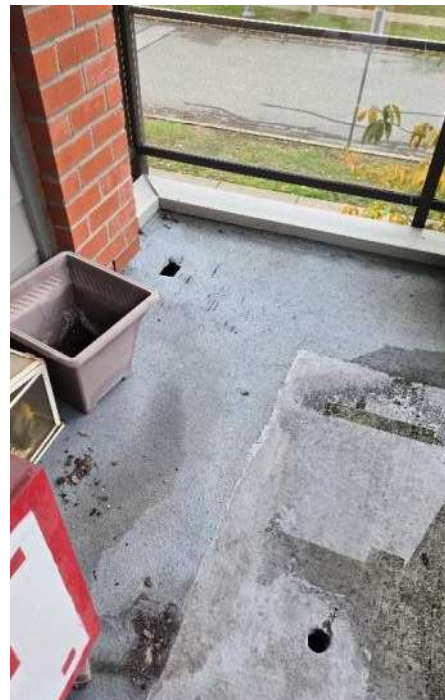
3.4.1 Balconies – Waterproofing Membrane

The balcony wood frame decking is protected with polyurethane traffic membranes.

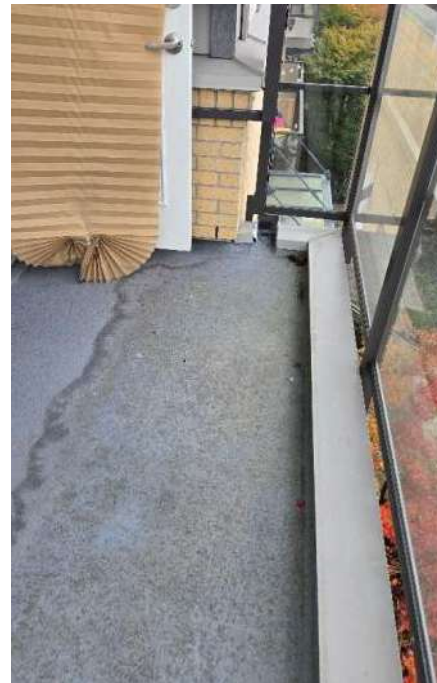
3.4.1 Balconies – Waterproofing Membrane

The balcony wood frame decking is protected with polyurethane traffic membranes

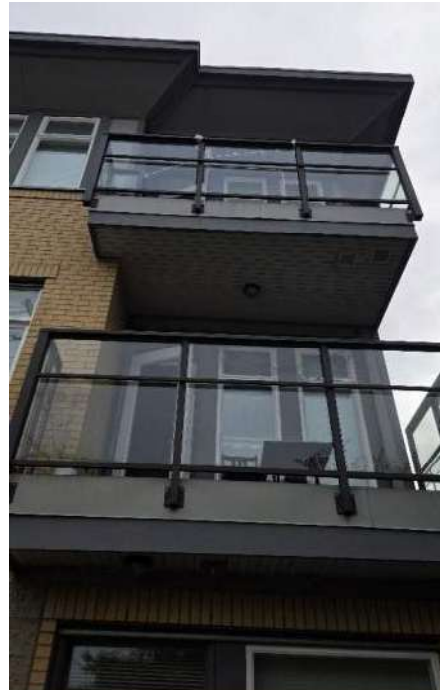
3.4.2 Balconies – Guardrails

The balconies have side-mounted aluminium guardrails with glass infill panels.

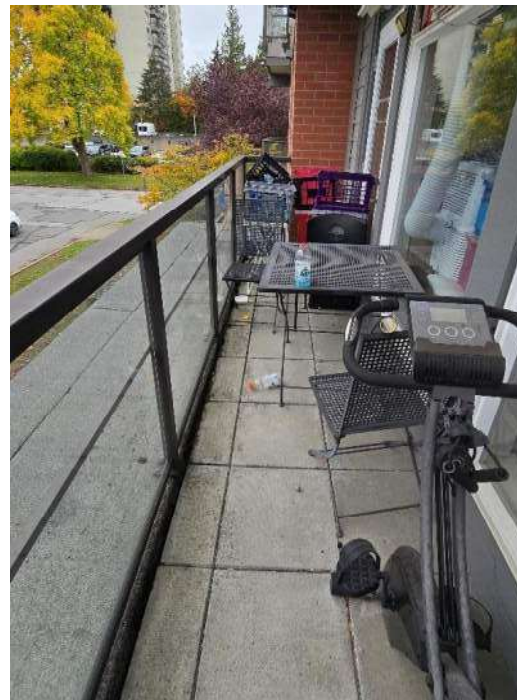
3.4.2 Balconies – Guardrails

The balconies have side-mounted aluminium guardrails with glass infill panels.

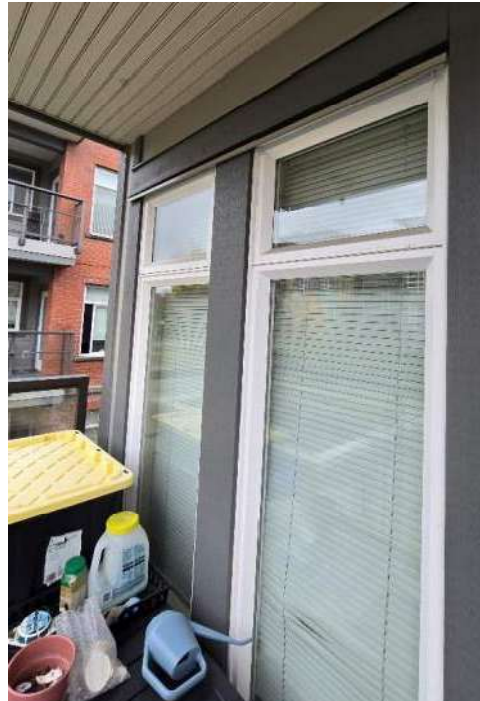
4.1 Window Systems

The window systems and sliding doors consist of insulated glazing units set in aluminium frames.

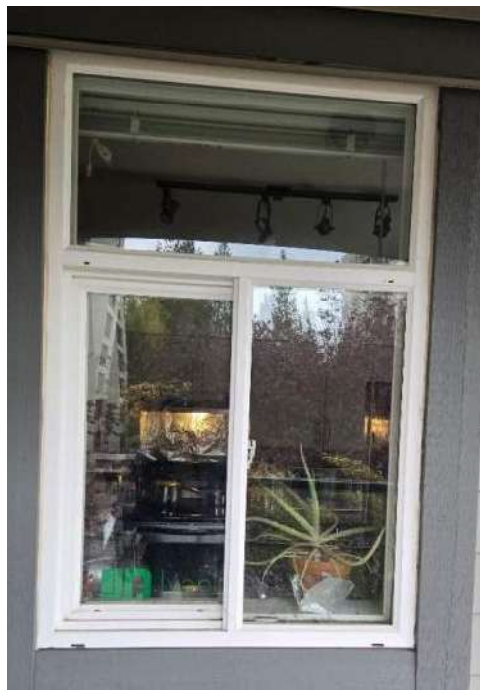
4.1 Window Systems

The window systems and sliding doors consist of insulated glazing units set in aluminium frames.

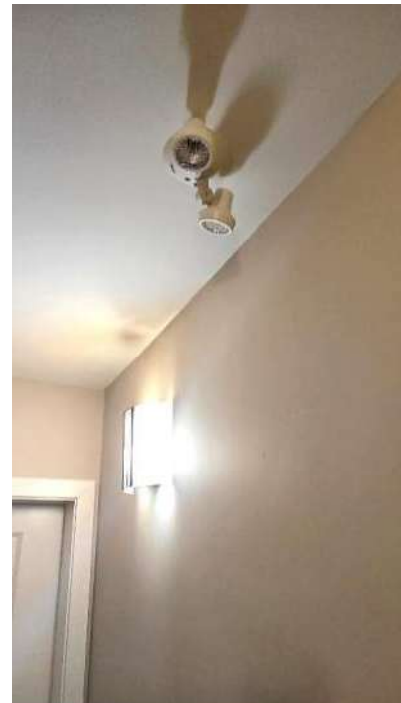
5.1 Interior Finishes – Paint (Building A)

Interior finishes in the common areas of building A such as paint, textured ceilings, and carpeting in common hallways along with light fixtures are typically replaced after 10 to 15 years, or more, as a result of wear, fading, new trends, or Owner’s desire for a change of appearance

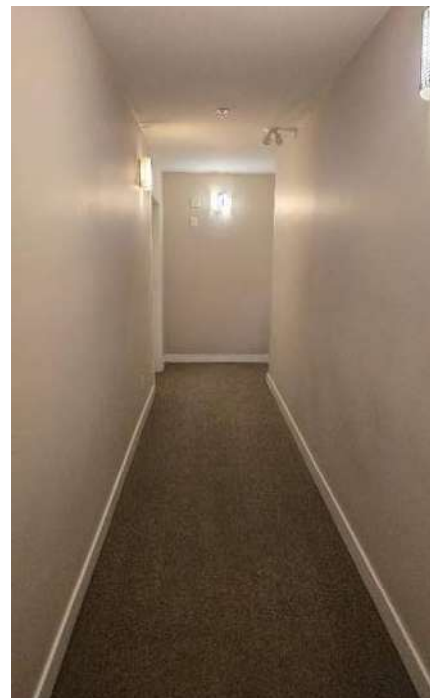
5.2 Interior Light Fixtures (Building A)

Interior finishes in the common areas of building A such as paint, textured ceilings, and carpeting in common hallways along with light fixtures are typically replaced after 10 to 15 years, or more, as a result of wear, fading, new trends, or Owner’s desire for a change of appearance

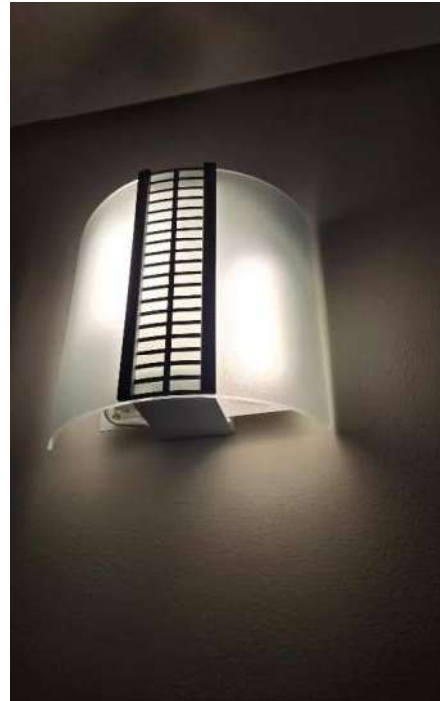
5.3 Hallway Carpet & Flooring – Replacement (Building A)

Interior finishes in the common areas of building A such as paint, textured ceilings, and carpeting in common hallways along with light fixtures are typically replaced after 10 to 15 years, or more, as a result of wear, fading, new trends, or Owner’s desire for a change of appearance

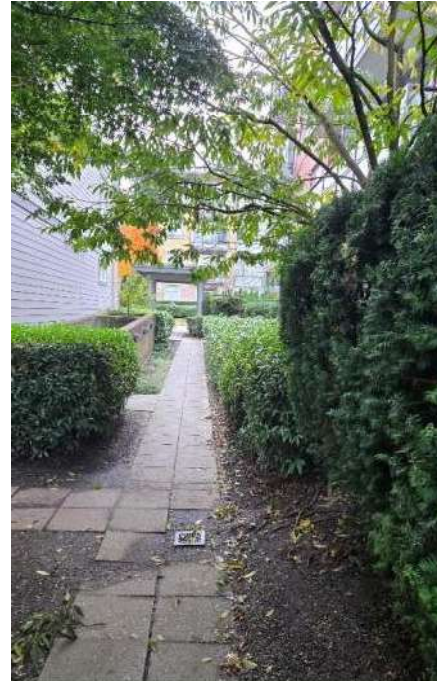
6.4 Soft Landscaping

It is assumed that annual landscaping maintenance such as weeding, pruning, etc. is funded from the operating budget.

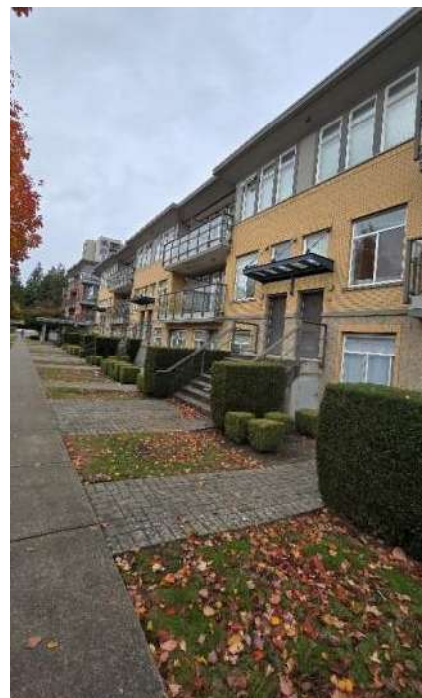
6.4 Soft Landscaping

It is assumed that annual landscaping maintenance such as weeding, pruning, etc. is funded from the operating budget.

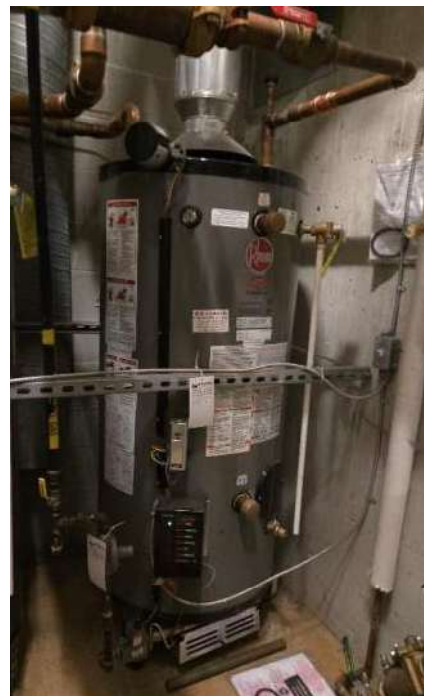
7.2.1 Domestic Hot Water

Domestic Hot Water serving Building A is supplied by two Domestic Hot Water Heaters.

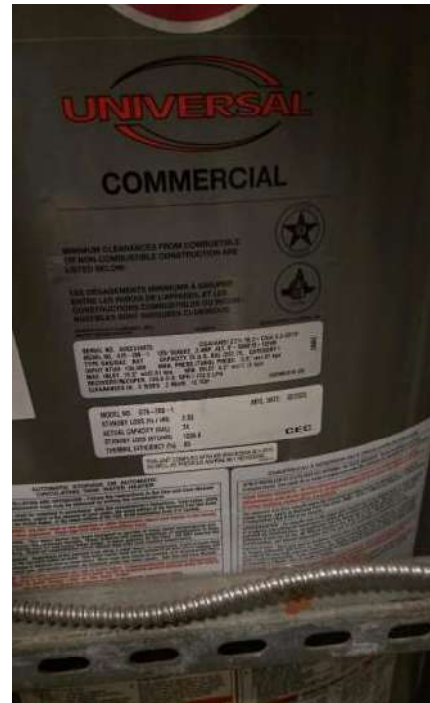
7.2.1 Domestic Hot Water

Domestic Hot Water serving Building A is supplied by two Domestic Hot Water Heaters.

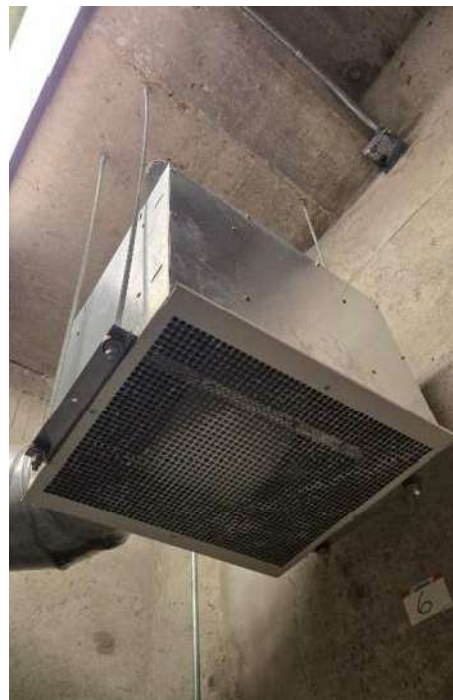
7.3 Service Area Fans

Various rooms in the parkade level such as mechanical, electrical, and storage rooms are provided with exhaust fans. These fans will have either manual switches or temperature sensitive controllers.

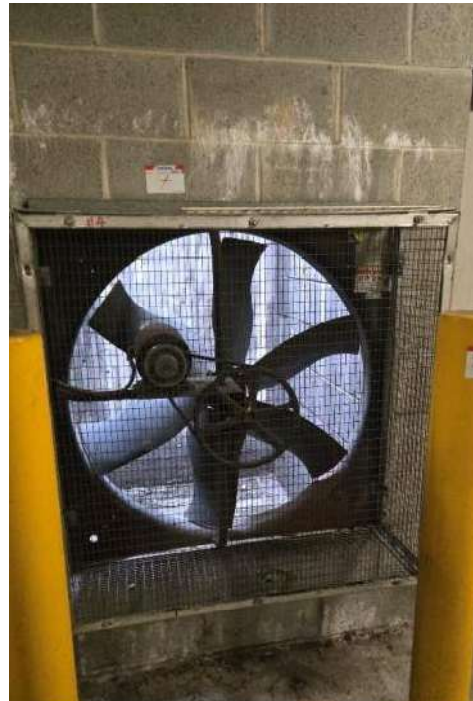
7.3.1 Parkade Exhaust Fans

There is a through wall exhaust fan serving the parkade. It is assumed that the distribution ducts will last the life of the building.

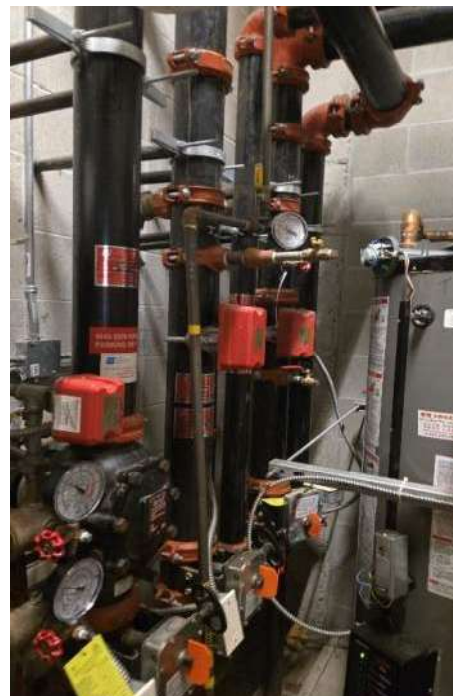
7.4 Fire Suppression System

The fire suppression system includes a dry sprinkler system serving the parkade, storage areas, and service rooms, along with a wet sprinkler system protecting all heated spaces in both buildings.

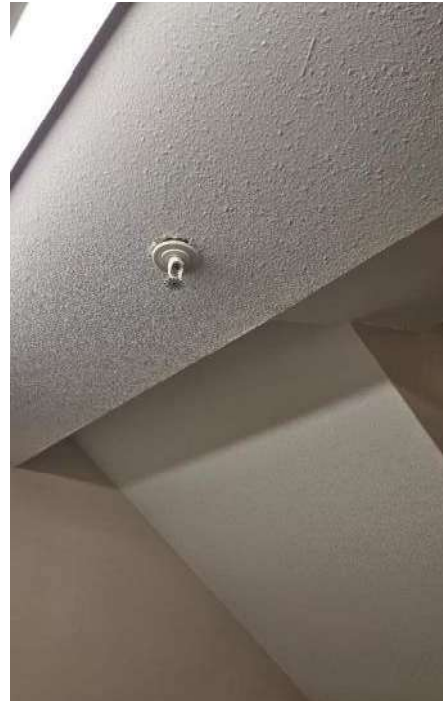
7.4 Fire Suppression System

The fire suppression system includes a dry sprinkler system serving the parkade, storage areas, and service rooms, along with a wet sprinkler system protecting all heated spaces in both buildings.

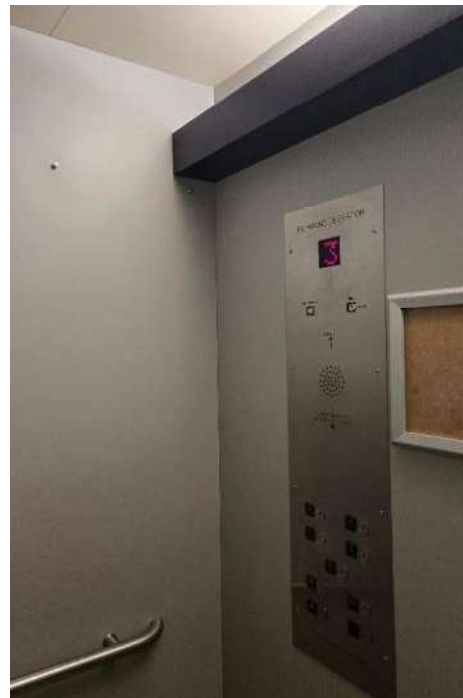
7.5.1 Elevator Refurbishment (Building A)

One “Richmond” hydraulic elevator serves Building A. Maintenance is currently being provided by Richmond Elevators. The elevator is reported to be reliable, and a review of the maintenance log indicates recent service calls have been primarily for scheduled preventative maintenance.

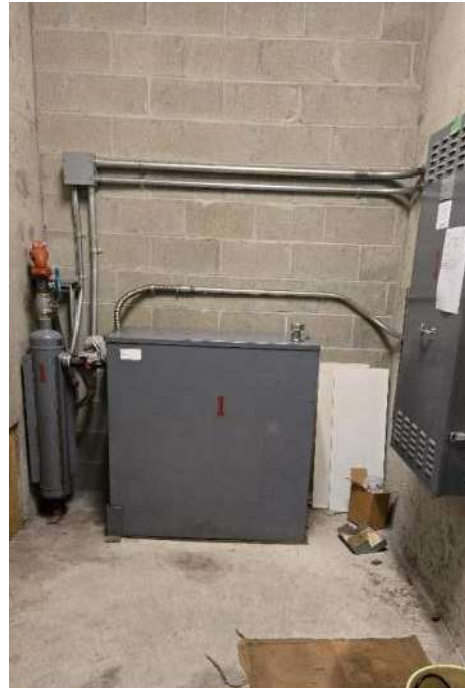
**7.5.2 Elevator Modernization
(Building A)**

One “Richmond” hydraulic elevator serves Building A. Maintenance is currently being provided by Richmond Elevators. The elevator is reported to be reliable, and a review of the maintenance log indicates recent service calls have been primarily for scheduled preventative maintenance.

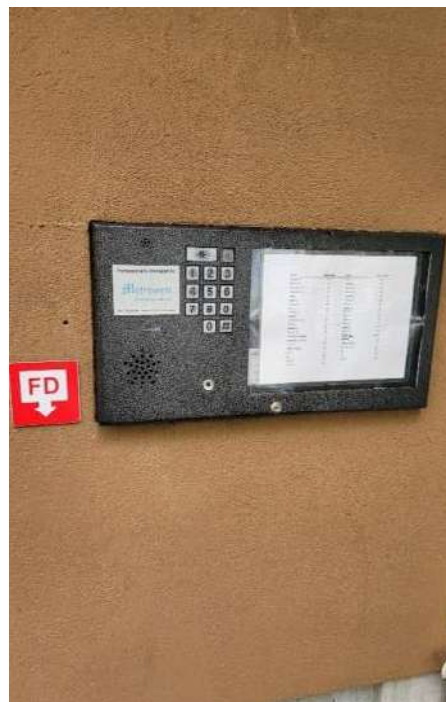
**7.6.1 Enterphone/Entry System
(Building A)**

The intercom system is mounted on the front wall at the main entry area located at the south perimeter of the site.

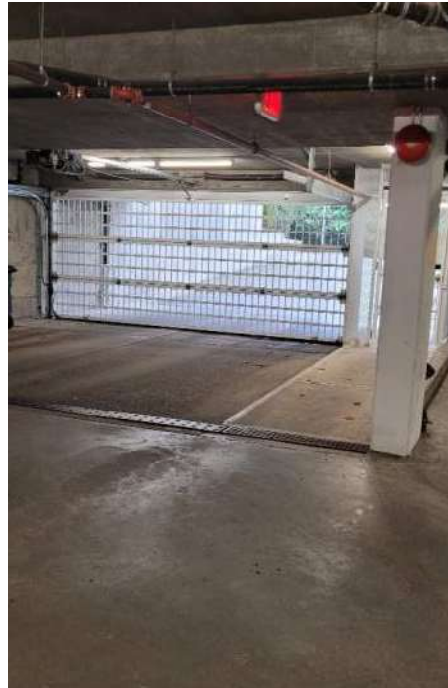
7.6.2 Parkade Overhead Gate

There is a single overhead door which allows access to the parkade.

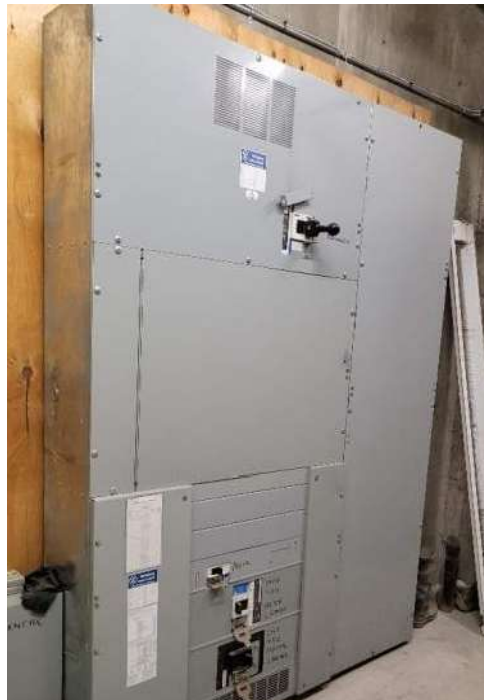
8.1.1 Electrical Allowance

The main electrical service for the building consists of a main 1200 amp “Westinghouse”, switchgear which then feeds a series of smaller switches, distributing power to the various loads within the buildings

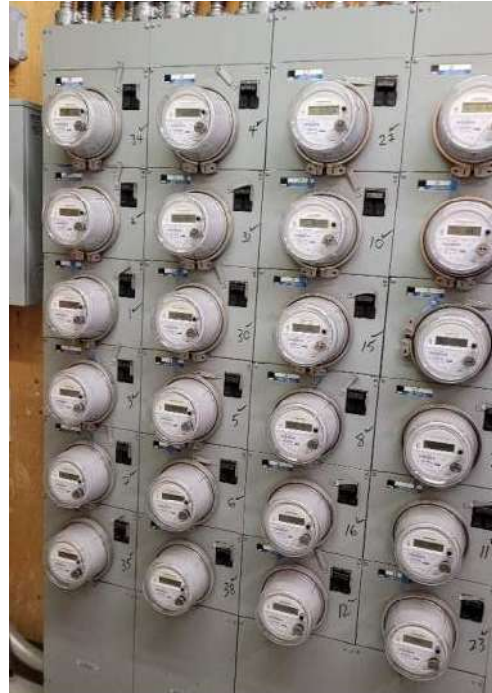
8.1.1 Electrical Allowance

The main electrical service for the building consists of a main 1200 amp "Westinghouse", switchgear which then feeds a series of smaller switches, distributing power to the various loads within the buildings

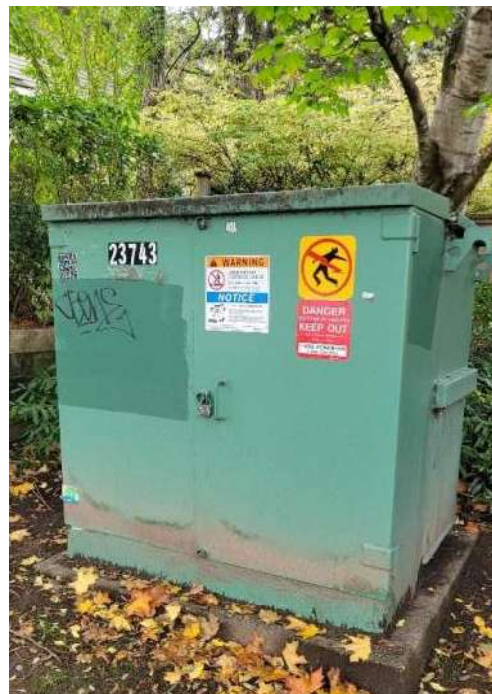
8.1.1 Electrical Allowance

The electrical power for the Site Building is supplied from a pad mounted transformer which is accessed from the west portion of the site and feeds the electrical room of the building via underground cables.

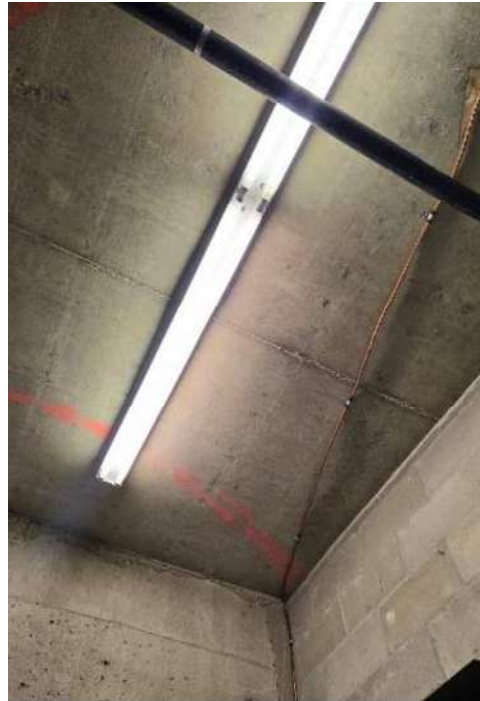
8.1.2 Parkade Light Fixtures

Parkade lighting is facilitated by a series of surface mounted fluorescent fixtures fitted to the parkade ceiling. Parkade lighting fixtures are mainly fed by conduit buried in the slab. These fixtures would be replaced out of the Operating Budget

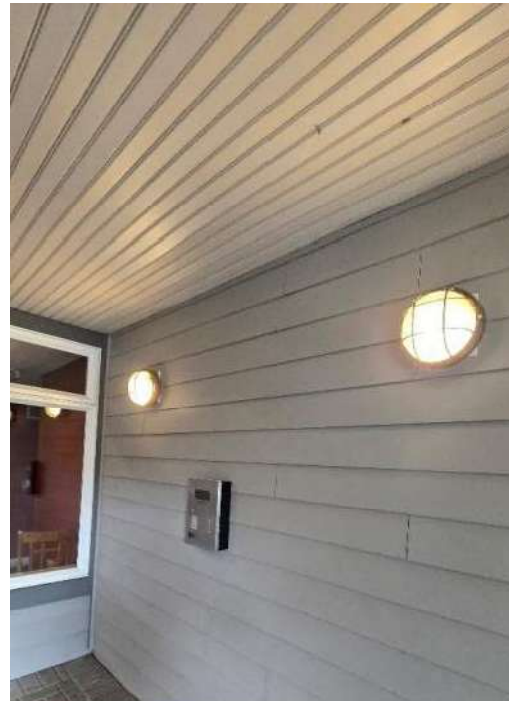
8.1.3 Exterior Light Fixtures

There are sets of exterior wall-mounted light fixtures that focus on the pathways within the Galleria development at unit entrances and at exterior walls overlooking balconies. The exterior light fixtures are in fair condition where observed.

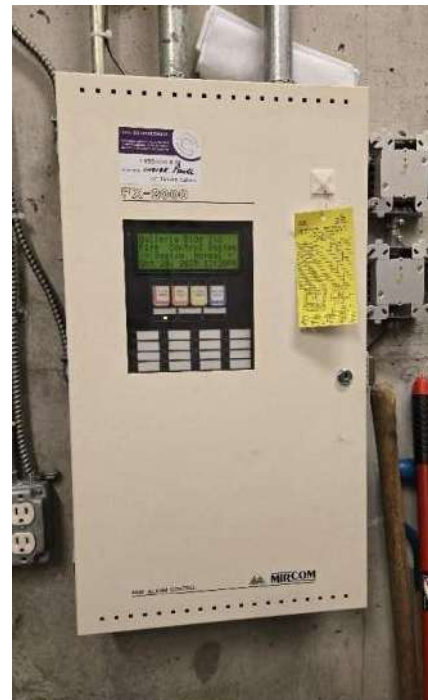
8.2 Fire Alarm System

The fire alarm system includes the signalling devices (gong stations, smoke detectors, and heat detectors), the control panel, the signal wiring, and the alarm devices.

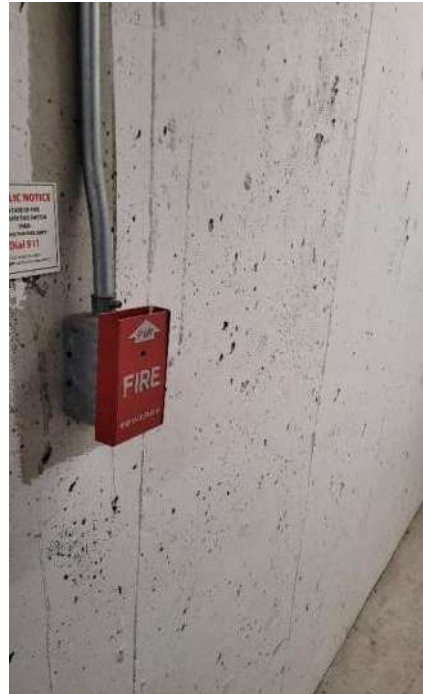
8.2 Fire Alarm System

The fire alarm system includes the signalling devices (gong stations, smoke detectors, and heat detectors), the control panel and annunciator panel, the signal wiring, and the alarm devices.
